Chemical Plant Heated Water Line

Texas, USA

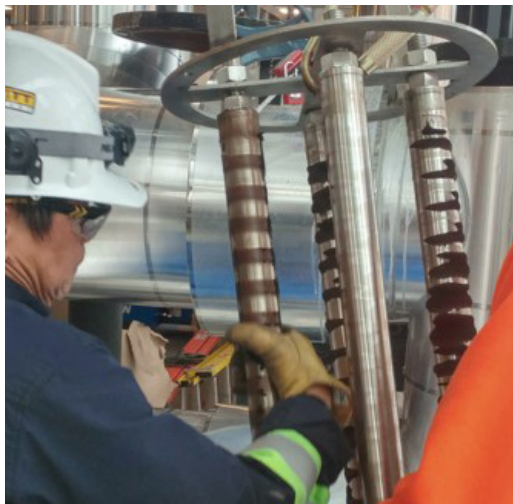
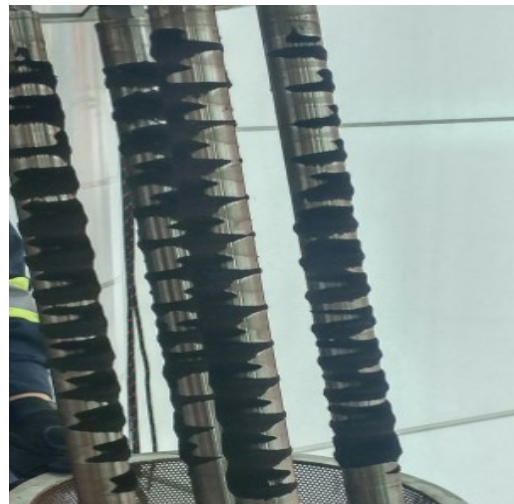
Contamination shown in the pictures was collected after 3 months of operation. Now the unit has been installed for 1.5 years, and the customer is looking to install BPS magnetic separator systems on their glycol systems and heat exchangers.

Install magnetic separator elements into existing basket strainer as a proof of concept.
