Natural Gas Fuel Dispenser Inlet

Italy

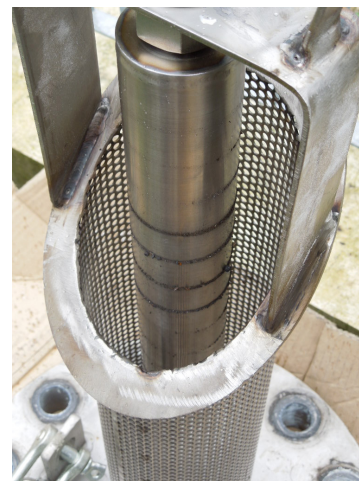
Analysis of the contamination collected indicated high levels of non-ferrous particulate caught by the magnetic elements

Particle Composition (ppm)			
Iron	> 2000	Silicon	417
Chromium	3	Sodium	46
Nickel	11	Vanadium	<1
Molybdenum	<1	Potassium	41
Aluminum	58	Calcium	196
Lead	20	Magnesium	60
Copper	13	Phosphorus	154
Tin	< 1	Zinc	93
Silver	< 1	Barium	< 5
Titanium	5	Boron	10

Install a high-pressure magnetic separator upstream of the compressor.

After the initial cleaning, a significant amount of ferrous and non-ferrous black powder was captured. The magnetic separator system is still currently installed and operating at full efficiency. No maintenance crews have been required to repair the compressors since its deployment.
