Case Study: Diesel Fuel Filtration July 2013

Weatherford Colombia Ltd. Gachanzipa D.C. Colombia

APPLICATION: Diesel Fuel Filtration

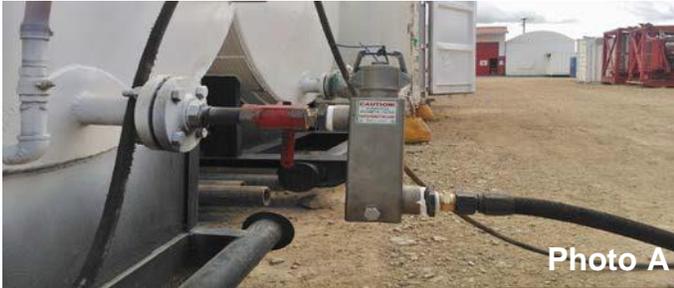
Photo A

RESULTS: Two consecutive filtration tests were conducted by installing the magnetic scrubber before (Test 1, Photo A) and after the conventional filters (Test 2, Photo B). In Test 1 the magnetic scrubber removed a large amount of contamination from the fuel down to sub-micron in size (Photo C). In Test 2 the magnetic filter again removed a similar amount of contamination from the fuel. This clearly identifies the inefficiency of traditional filtration to remove the most damaging contamination (Photo D).

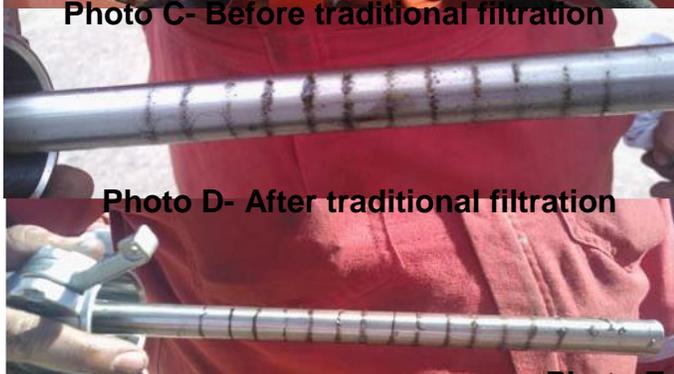
Photo C- Before traditional filtration

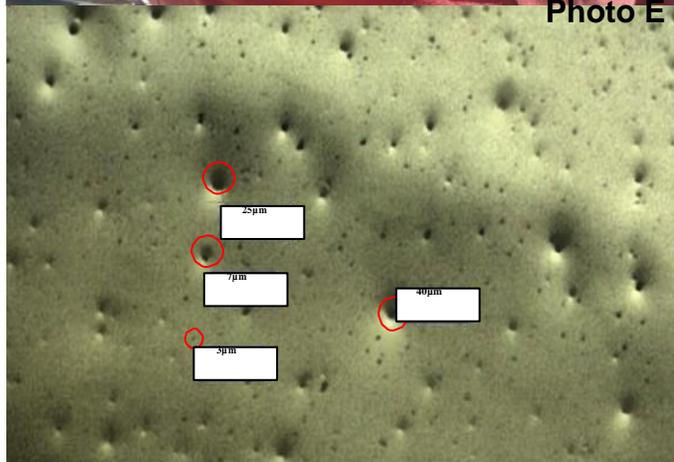
This metal contamination cuts holes in the traditional filtration media (known as worm holing) causing channeling of the fuel. This increases the wear rate of injection fuel systems and may generate particulate matter emissions PM10 & PM2.5.

Photo D- After traditional filtration
