Magnetic Filtration Case Study

Solvay Chemical Plant

APPLICATION: De-mineralized Water Injection Cleaning System for Turbine Rotors

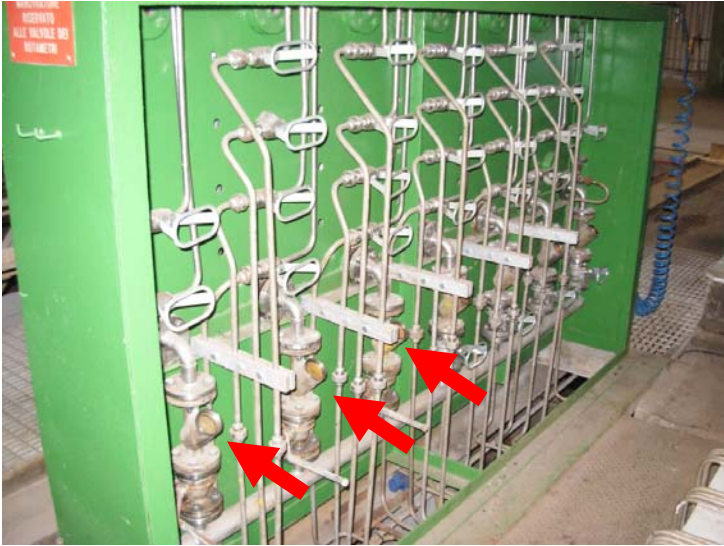
SOLUTION: Alex Priori of Renox, a distributor for OEI, suggested the installation of multiple ½" x 4" OEI magnetic filter rods into existing Y-Strainers on the Steam Turbine (Photo A) to decrease the amount of ferrous metal contamination.

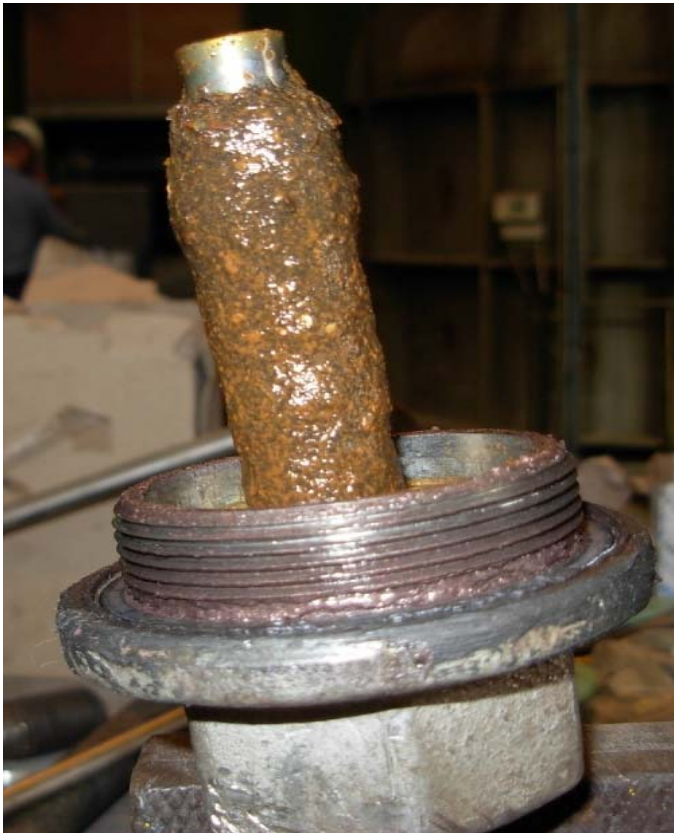
RESULTS: Photo B shows the accumulation of ferrous metal contamination including a vast amount of rusted material captured by a magnetic filter rod after 30 days in operation.

The OEI magnetic filter is easily cleaned and the trapped contamination analyzed for component wear identification allowing for predictive maintenance planning.
