# Glycol Circulation Pumps

Italy

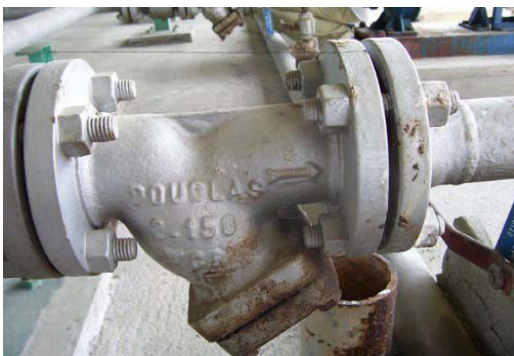
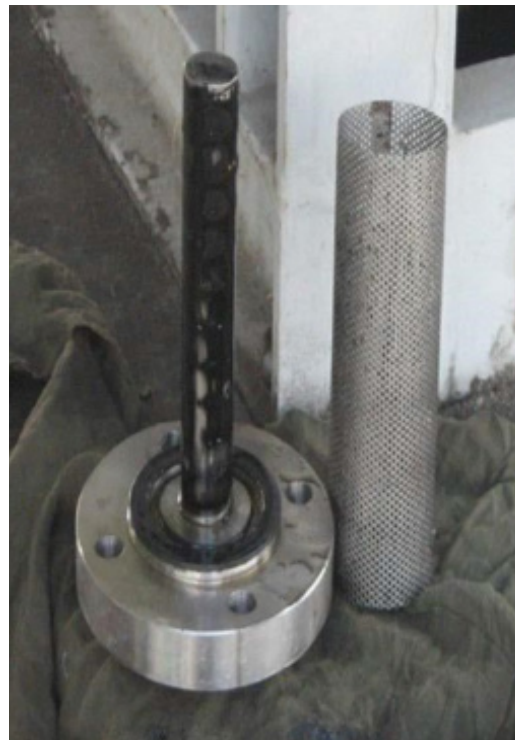
Install a magnetic separator upstream of six pumps to test its capability of removing black powder contamination to sub-micron levels.

A significant amount of black powder was removed from the glycol system that otherwise would have easily passed through mesh screens. Since installing the magnetic separator systems in 2008, the pumps have operated at full efficiency without failure.
