LPG Loading Facility Compressor Lube Oil

Targa Resources - Galena Park Facility, Houston, TX USA, 2017 - 2021

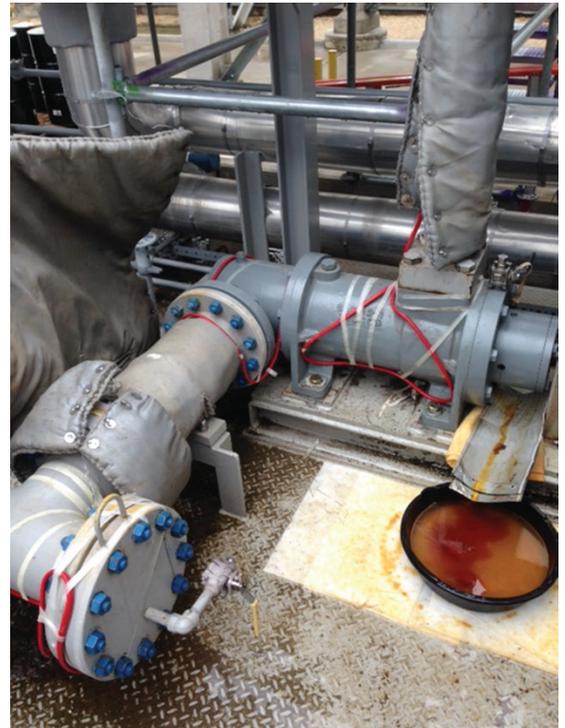
High levels of Black Powder contamination (iron oxide, iron sulfide, silica and salts) from feed stock were bypassing filtration, contaminating compressor lube oil and damaging pumps, bearings, and seal faces. Two filtration methods were in use – a cone strainer upstream of the pump and high-pressure cartridge filters upstream of the compressor. The cone strainer was ineffective in removing Black Powder as it occurred in large quantities of particle sizes below 5 microns in size, resulting in premature repairs and replacement of the pump. On average, one pump was replaced every year, costing \$65,000.

Figure 1. Constant seal leakage from IMO Lube Oil Pumps.

A BPS Magnetic Separator was installed upstream of the pump, replacing the cone strainer. The existing cartridge filters remained in service.

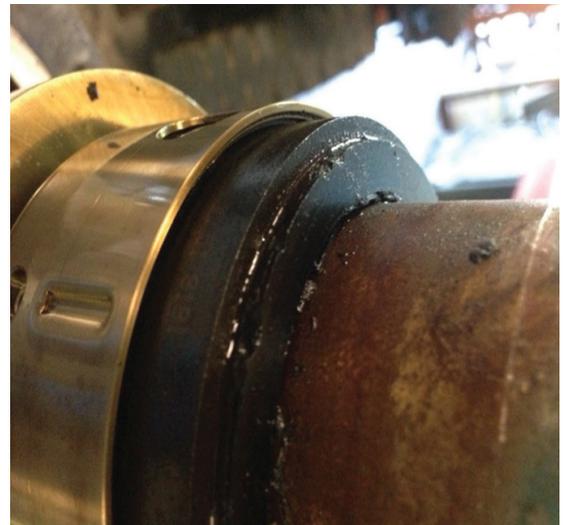
Slugs of contamination would frequently plug off the cartridge filters, allowing the Black Powder to bypass directly into the compressor lube oil. The cartridge filters required replacement several times a week. Several seals were being replaced every year, at a cost of \$5,000 each. Compressor bearings were also occasionally replaced at a cost in excess of \$50,000.

Figure 2. Black Powder contamination on the seals.

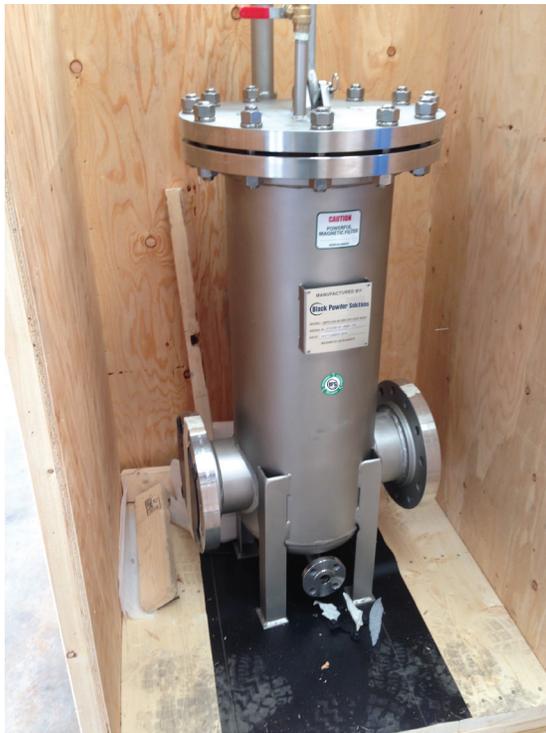
Figure 3. Black Powder Solutions Magnetic Separator

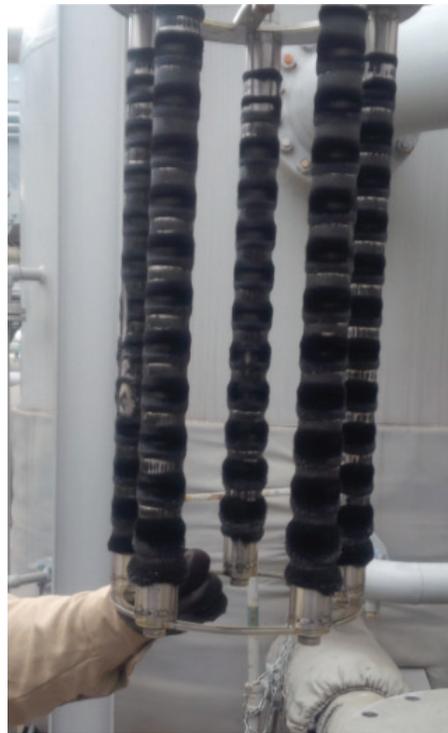
Once in operation, the separator removed virtually all the Black Powder, with no evidence of contamination on the cartridge filters. The BPS system has the capacity to hold months of contamination, eliminating the cartridge filter changes that were occurring every few days. The BPS system operates without flow restriction, no pumps have been replaced and unscheduled maintenance has been drastically reduced. Due to this, opportunities for accidents and spills have been minimized and the terminal is operating with a smaller carbon footprint. The compressor has been operating much more reliably. The client subsequently decided to install 8 additional BPS units.

Figure 4. Black Powder contamination captured by the magnetic elements.
