Pigging: Condensate Pipeline

Saudi Arabia

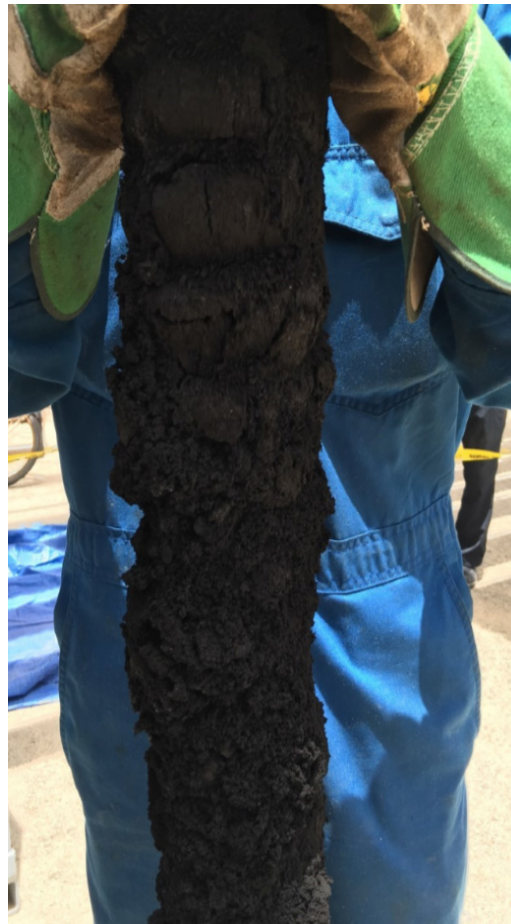
As a proof of concept, the customer installed a 5" OD, 300#, 316 SS magnetic separator skid, on a 1" OD slipstream line, off of a 14" OD pipeline, for 8 days to test:

The BPS system was tested after pigging operations, and 2.9 kgs of black powder was captured.

After the 8 days, testing showed the conventional filtration plugged off and caused a 25 psi pressure drop. In comparison, the BPS system registered 0 psi pressure differential while loaded with contamination.
