## Transmission Line Black Powder Removal Test

12" Gasoline, Diesel Fuel, and Light Oil Transmission Pipeline from Edmonton—Vancouver  
Kinder Morgan, BC, Canada, 2010

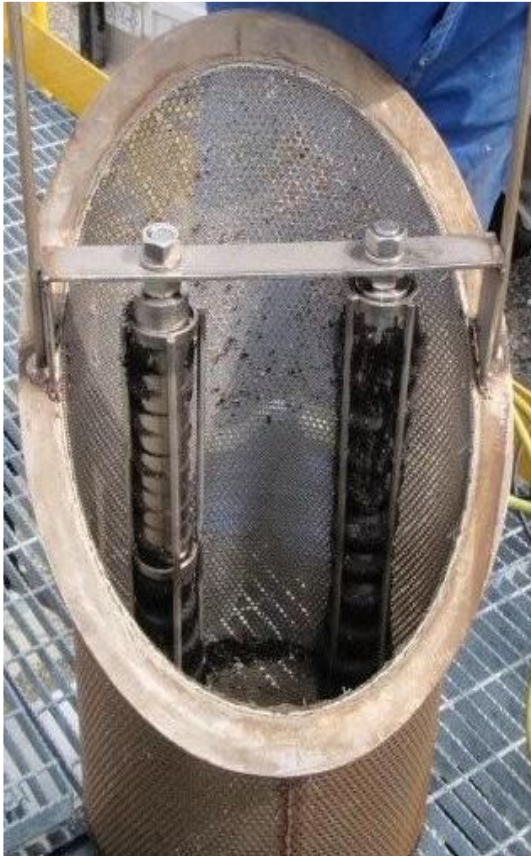
Install two 24" long 2"OD Magnetic Separators into existing carbon steel basket strainers in the tank farm.

A significant amount of Black Powder contamination was collected by the Magnetic Separators.
