Off-shore Platform Glycol Dehydration

Adriatic Sea, Italy / 2015

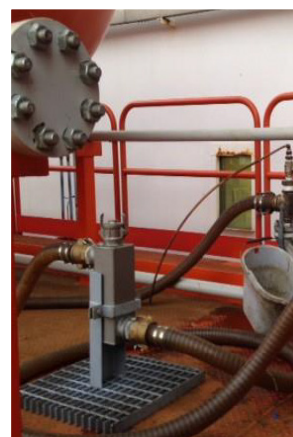
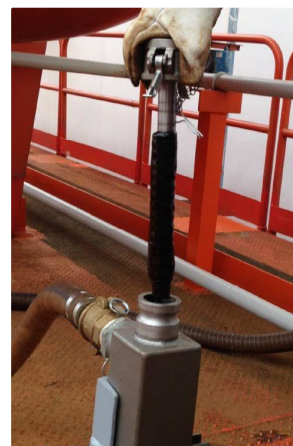
Analysis of contamination collected on the magnetic element showed 74% non-ferrous particles and 26% ferrous. The glycol quality was significantly improved with minimal maintenance requirements.

Install a magnetic separator after the reservoir to improve glycol quality.
