Case Study: Compressor Lube Oil  
November 2013-January 2014

## Eni S.p.A Ravenna, Italy

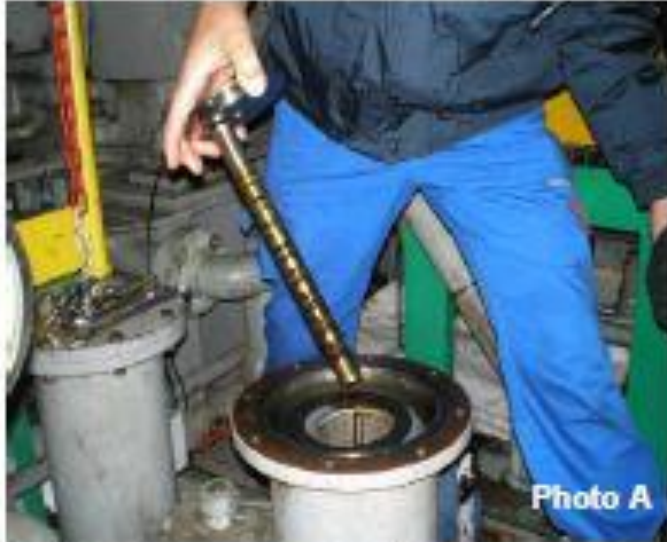
Photo A

**PROBLEM:** Oil analysis identified a high level of wear contamination in the NP#2 compressor lube oil. If left in the system will cause premature wear of the compressor components. Traditional filtration was unable to remove this contamination under 10 microns and the most damaging contamination is iron and steel under 10 microns. The inefficient disposable elements caused increased change outs and maintenance intervals.

**SOLUTION:** Alex Priori of Renox, OEI distributor, suggested a test installation of their magnetic rod in the existing housing to remove the wear contaminants to sub-micron levels and extend the change out and maintenance intervals.

**RESULTS:** The ROI is clearly identified as the decrease in wear contaminants reduced the wear on the compressor components, decreased element change out and extended maintenance intervals.
