Magnetic Filtration Case Study

OROGEL GROUP

47020 - Pievesestina di Cesena (FC) - Italy
February 2007

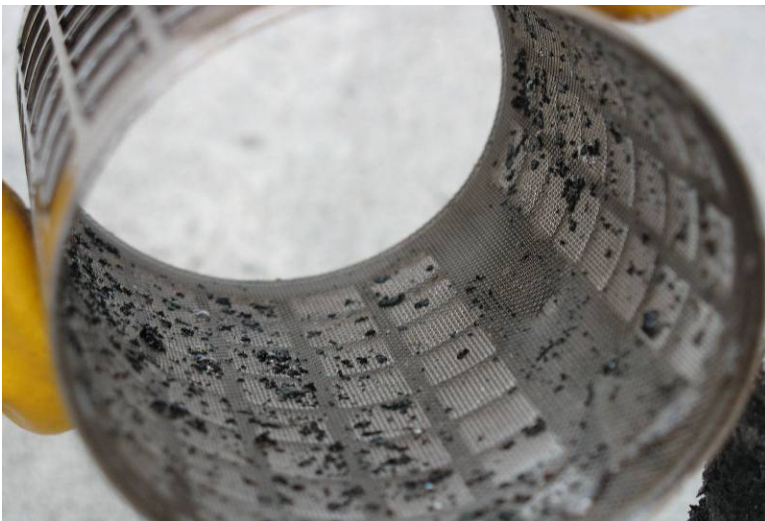
SOLUTION: Install an OEI Magnetic Filter Rod (2RNC386) modified to mount on the pre-filter housing of the lube oil line.

RESULTS: This compressor has 352 hours of running time on it. This is the fourth time this filter has been cleaned. As you can see the OEI magnetic filter has once again extracted a significant amount of ferrous metal. The filter itself has trap fair amount of non-ferrous contaminants also. **"It's plausible to believe that this product will increase the longevity of our equipment."**
