Case Study: Trimethoxy(methyl)silane Filtration April 2012- June 2013

Momentive Performance SRL Termoli, Italy

APPLICATION: Circulation Pump

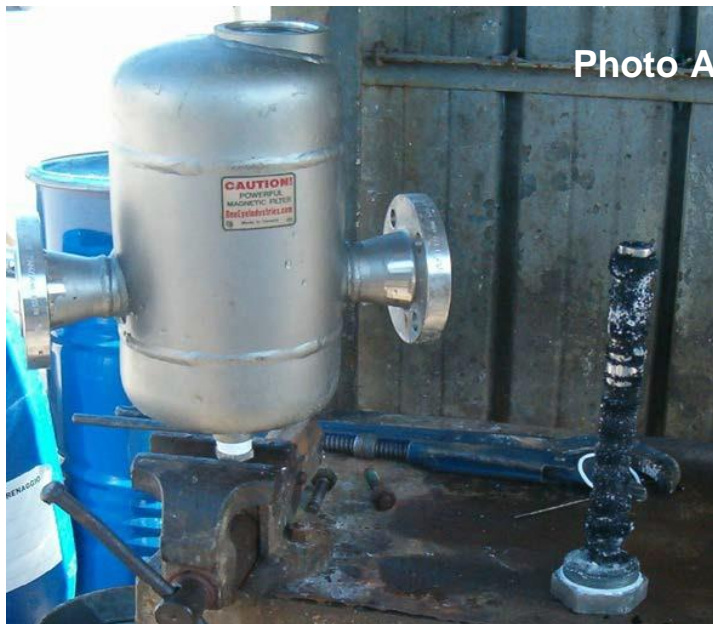
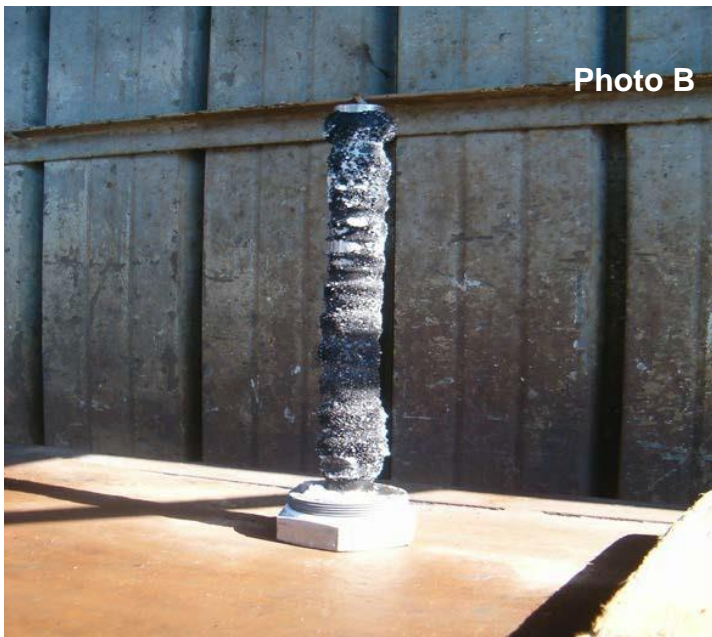
Photo A

PROBLEM: Premature failure of the pumps and seals due to excessive ferrous metal contamination as a result of erosion and corrosion of the piping caused by the dangerous process fluid Trimethoxy(methyl)silane (CAS number 1185-55-3).

RESULTS: Photos A & B show a substantial amount of ferrous metal contamination captured by the OEI magnetic filter rod after approximately 4 months in operation. In the past 14 months there have been no pump failures and maintenance intervals have been extended reducing contact with the Trimethoxy(methyl)silane when replacing failed pumps.

SOLUTION: Alex Priori of Renox, the OEI distributor in Italy, suggested the installation of a special high pressure OEI Scrubber prior to the circulation pump on the suction side to filter out the fine ferrous metal contamination that was causing premature failure of the pumps and seals.

RECOMMENDATION: Install OEI magnetic filters to reduce pump wear, supply a cleaner product and opportunities for injury by reduced contact with dangerous chemicals. This filter also allows for predictive maintenance planning. For more information, contact our office at 877-888-8727 or visit our website at www.oneeyeindustries.com
